RE: STV 7.3 33GoldSt(SC,C,M,1-7,R),MH- ADA Initial Report

As per your request, we have reviewed the complaint Civil Action No (1:19-cv-09674-JMF) brought against defendants (Harold Thurman, Brad Thurman, and 33 BRE Inc.) for the premises referenced above. The complaint alleges failure to comply with the American Disabilities Act of 1990.

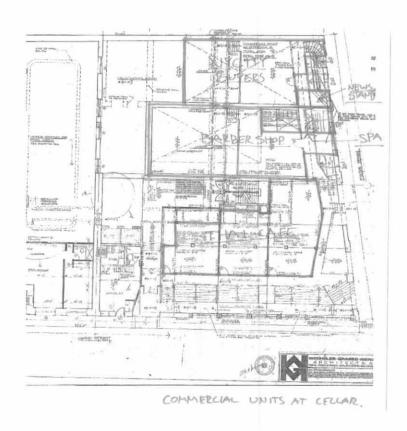
Exhibit 1: Diagram of locations of units referenced in complaint

Affina Nail Spa is located at the Cellar Mezzanine level, and accessed via a balcony at approximately +3'9" above grade.

Asia Wok is located at the Cellar Mezzanine level, and accessed via a balcony at approximately +6'6" above grade.

Tandoor Palace is located at the Cellar Mezzanine level, and accessed via a balcony at approximately +6'6" above grade.

Mr. Rafaels Cleaners and Tailoring is located at the Cellar Mezzanine level, and accessed via a balcony at approximately +6'6" above grade.

Nycity Buyers is located at the Cellar level, and accessed via open steps down from the sidewalk to approximately -2'5" below grade.

Isaak Fulton Hair Cutter is located at the Cellar level, and accessed via open steps down from the sidewalk to approximately -2'5" below grade.

Bennie's Thai Café is located at the Cellar level, and accessed via lower concourse and open steps down from the sidewalk to approximately -2'5" below grade.

Wall Street Bath & Spa, also referred to as Physical Culture Establishment (PCE), is located at several levels below grade, with access via open steps down from the sidewalk to approximately -2'5" below grade.

According to the drawings and our observations of the exterior conditions, the commercial units are located on three different levels both above and below the city sidewalk. The greatest change in level would require a ramp at least 78' long at the appropriate 1:12 slope. Such ramps would be obstructions to the entry, the stairs, and the city sidewalk circulation.

We are in the process of studying ramps and other avenues of remediation in terms of the available space, changes of level to be accommodated, and the structural framing which may permit or inhibit ramps or other manner of remediation.
